Macro-microstructural studies of stress corrosion cracking (SCC) of mild steel in simulated environments

Abstract

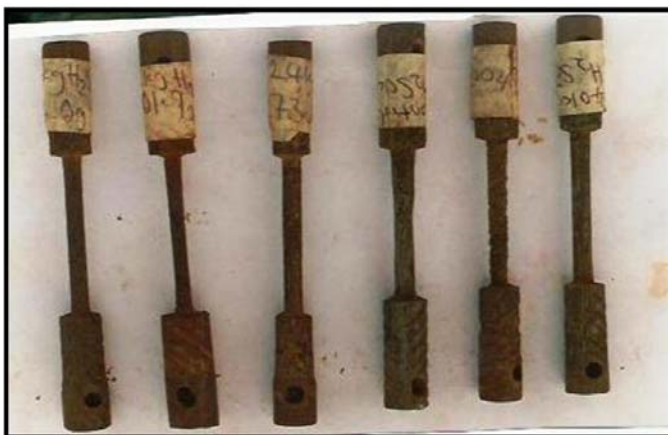
Plate 1: Macrograph of specimens tensed to various levels of stress in $1MH_2SO_4$ environment.

Visual inspection of the specimen shows that those stressed in H₂SO₄ (plate 1) were seriously attacked by the environment. Presence of stresses on the specimen surfaces made them to neck with obvious appearance of notches and cracks on these surfaces. These cracks were not just surface cracks, but were believed to have propagated into the specimen. It was also observed that those specimen stressed in 1M HCl (plate 2) were moderately attacked by the environment as cracks and notches were sparsely seen on their surfaces. Therefore, sulphuric and hydrochloric acid environments propagate SCC and other forms of corrosion on mild steel. Moreso, plates 3 and 4 which represent those specimens tensed in NaOH and H₂O respectively were not attacked. It clearly shows that mild steel is not susceptible to SCC in these environments. Further macroscopic investigation revealed that those specimens stressed in H₂O environment suffered from uniform corrosion

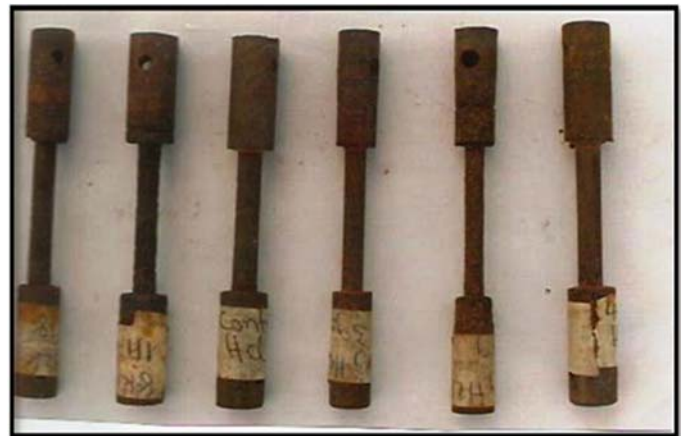
Plate 2: Macrograph of specimens tensed to various levels of stress in $1MHCl$ environment.

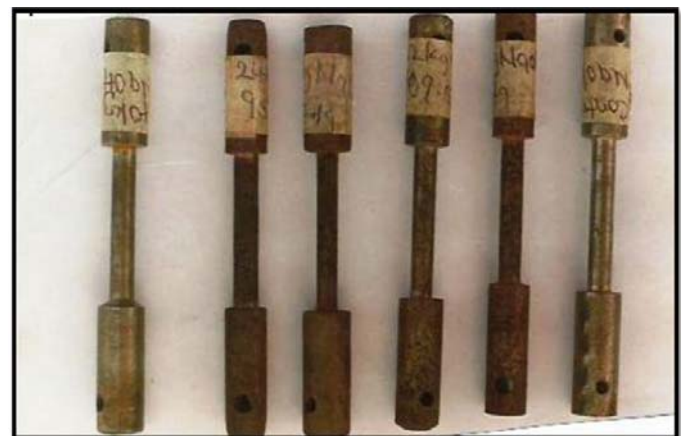
Plate 3: Macrograph of specimens tensed to various levels of stress in $1MNaOH$ environment.

to relatively low rate while NaOH was discovered to be an inhibitor on mild steel as those specimens stressed in its solution were seen with their lustre colour thorough out the experimental period. Consequent upon this, NaOH and H₂O environments do not propagate SCC on mild steel.

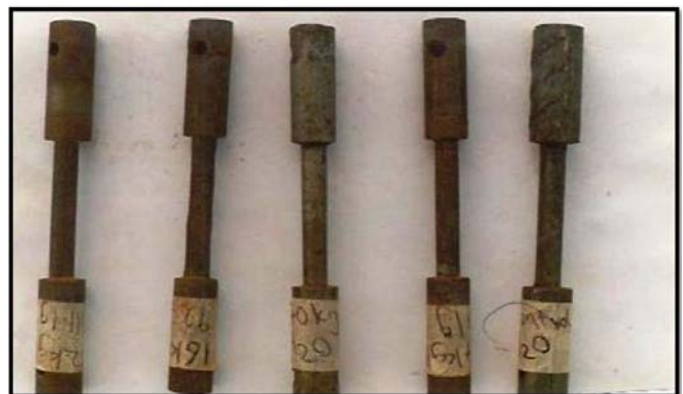
Plate 4: Macrograph of specimens tensed to various levels of stress in H_2O environment.

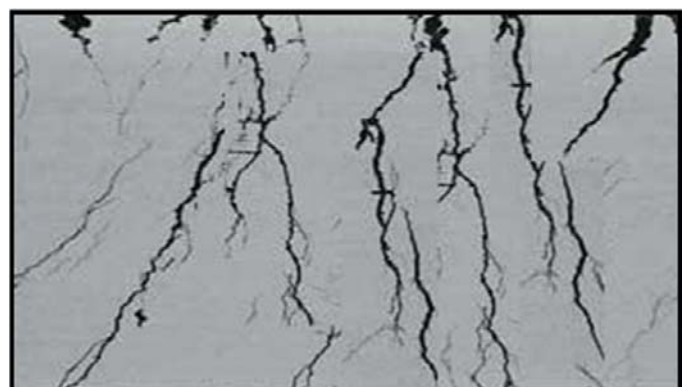
Plate 5a: Micrograph of specimen tensed to $253.6N/m^2$ for a period of 360 hours in $1MH_2SO_4$ environment. (x500), temp ($25^\circ C$).

The microstructures of specimens used in the four environments studied are presented in plates 5 - 8. Plates 5(a-e) represent those specimens stressed in 1M H₂SO₄ at various levels of stress. Microstructural examinations revealed levels of initiation and propagation of cracks in each of the micrographs examined. It was also observed that the higher the level of stress the more pronounced were the development of cracks in each specimen, with plate 5a seen to experience sever cracks while plate 5d had less crack. It was also discovered that plate 5e (control micrograph) had no crack.

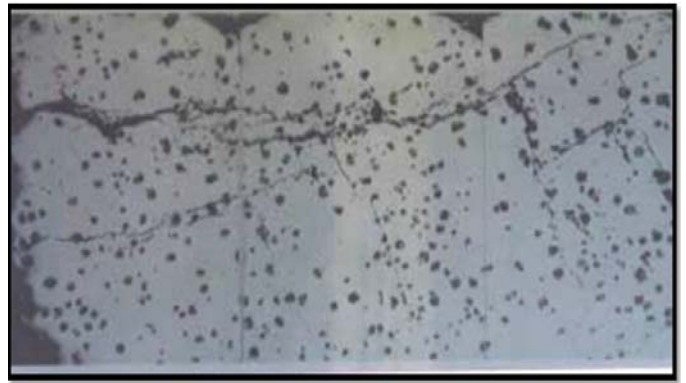
Plate 6a: Micrograph of specimen tensed to 253.6N/m² for a period of 360 hours in 1MHCl environment. (x500), temp (25 °C).

These developments are in conformity with what was observed in plate 1 earlier discussed. Furthermore, plates 6(a-e) represent microstructures of those specimen stressed in 1M HCl acid environment under various levels of stress. Crack initiation and propagation were observed to increase as the levels of stresses increased except for the control plate (6e) which has no crack. However, developments of these cracks were less when compared with those specimens that were stressed in sulphuric acid environment. Generally SCC and other forms of corrosion propagate in these two environments. An explanation to these could be based on three conditions necessary for SCC to occur which had earlier been discussed in the literature of the work. They are (1) Hydrogen embrittlement (2) Film-induced cleavage and (3) Active path dissolutions. However, theories of transgranular and grain boundary cracks also gave a clearer explanation to these behaviors. Finally, fractures of mild steel in these environments are very much possible (Parkins R. N. 2002) [11]. Plates 7 and 8 represent microstructures of those specimens stressed in 1M NaOH and water environments respectively. At the highest level of stress used in this experiment, specimens in these environments never suffered any form of SCC. The result is in conformity with the plates 3 and 4 earlier discussed. It shows that these environments do not propagate SCC. Explanation to this could be attributed to the behavior of neutral solution like water on steel. It states that when steel is exposed to near-neutral solution like water, the solubility of the protective oxide will be much lower than in acid solution and the extent of dissolution will tend to be smaller (Moore, J.J. 1981) [4]. It also further states that if the near neutral solution contains inhibiting anions like sodium hydroxide, the dissolution of the oxide film may be suppressed and the oxide film stabilized to form a passivating oxide film which can effectively prevent the corrosion of the metal which is then in the passive state. More so, one other factor that is known about SCC is that for many metals, if cathodic polarization is increased by methods of deoxygenation, inhibitors or cathodic protection, SCC may be delayed or eliminated (Moore, J.J. 1981) [4]. This may be an example of what happened in sodium hydroxide (NaOH) and (H₂O) environments since these environments are easily polarized cathodically, deoxygenated and not aggressive on mild steel.

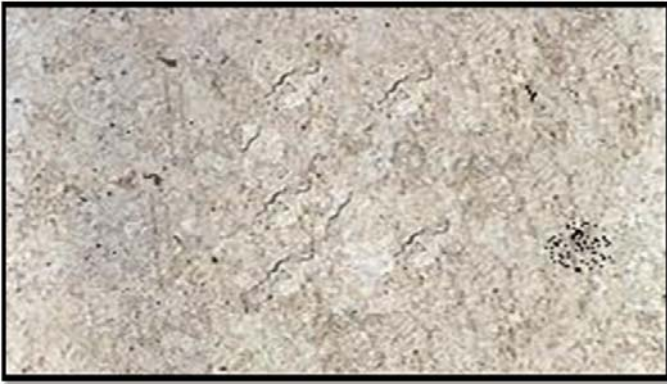
Plate 6e: Micrograph of control specimen immersed in 1M HCl environment for a period of 360 hours. (x500), temp (25 °C).

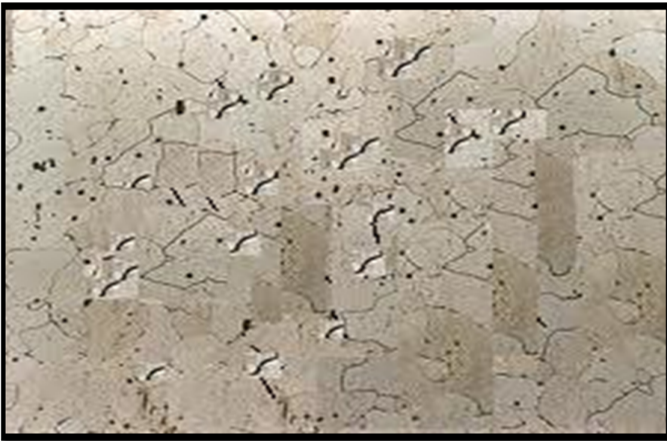
Plate 7: Micrograph of specimen tensed to 253.6N/m² for a period of 360 hours in 1M NaOH environment. (x500), temp (25 °C).

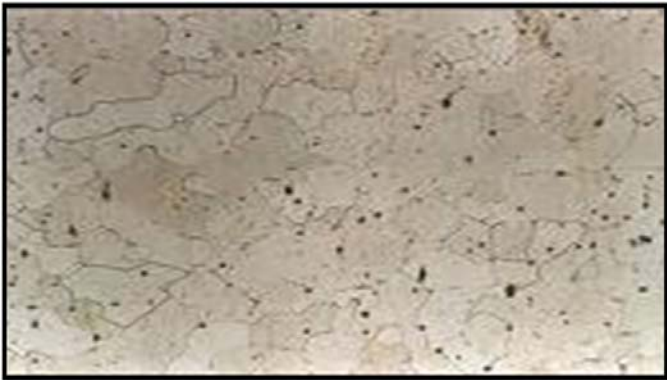
Plate 8: Micrograph of specimen tensed to 253.6N/m² for a period of 360 hours in H₂O environment. (x500), temp (25 °C)
