Increasing vulnerability of building stocks of Gangtok Town, Sikkim (India): An Issue and challenges for local people after Earthquake of 18th September 2011

Passang Tamang

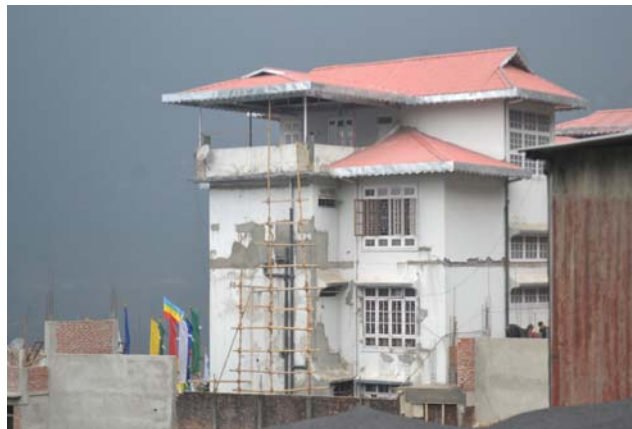
Fig 2: Severe damage building under repair

In this building case, this building is severely damage, find structural and non-structural damage, all columns form crack. Instead of demolish, they are repairing in all effort. This building is much vulnerable, if any earthquake happen in future.

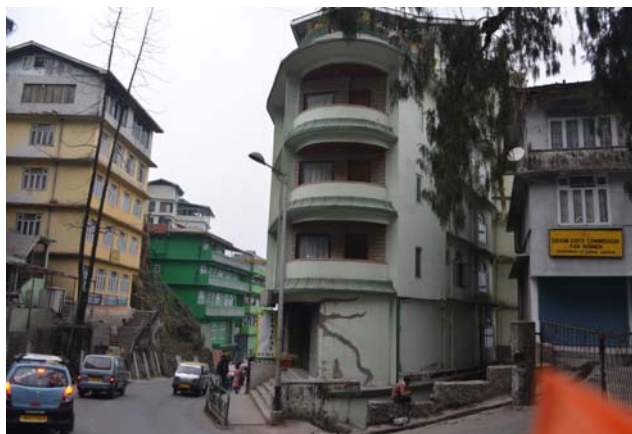
Fig 3: Several structural cracks identified 6 multi stored building

In Fig. 3, Arithang ward sample building, several cracks have been identified in the all floors of building; road level floor's crack is vivid from far distance. The vibrations caused by daily running vehicles may make much vulnerable to collapse the buildings. The second one fig. 1.16 building have combined wall and form several cracks during earthquake shows much vulnerable.

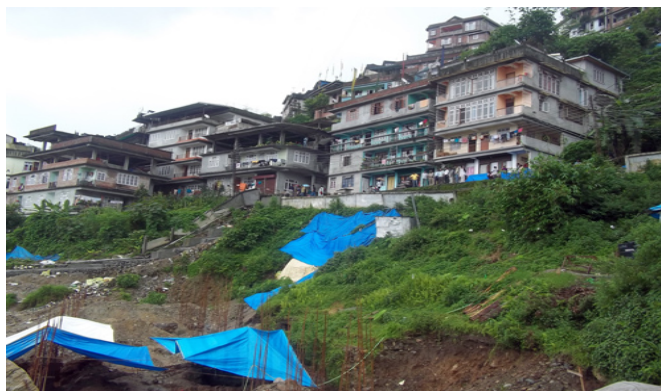
Fig 4: Possible of buildings vulnerability at Daragoan

Some of the building under Daragoan ward is overloaded by multiple parallel floors and ground floor is severely damage during earthquake, some of the building are constructed in

sinking zone with multiple parallel floors add above may pose serious threatening in future.

There is a possibility of land failure due to below construction of college hostel in Daragoan. The above lying buildings base is becoming unstable and more prone for landslide.

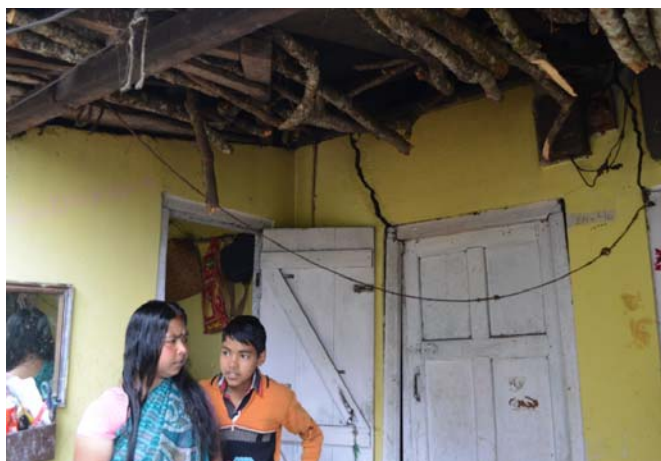
Fig 5: Kuccha house with severe damage

The sample of taken Buildings under Syari-Tathangchen ward fig. No. 5 considered Kuccha house, during earthquake it was severely damage and still people occupy this house. This house has low seismic resistance capacity, if same intensity of earthquake strike, there will be chances of more life to claim in near future.
