Accessible design: University campus planning review

This study investigates the problems of individuals with disabilities who are using or using Istanbul Sabahattin Zaim University Halkali Campus access to the campus via the Islamic Economic and Faculty of Education buildings samples and to determine the deficiencies in the current usage and the problems of the disabled individuals.

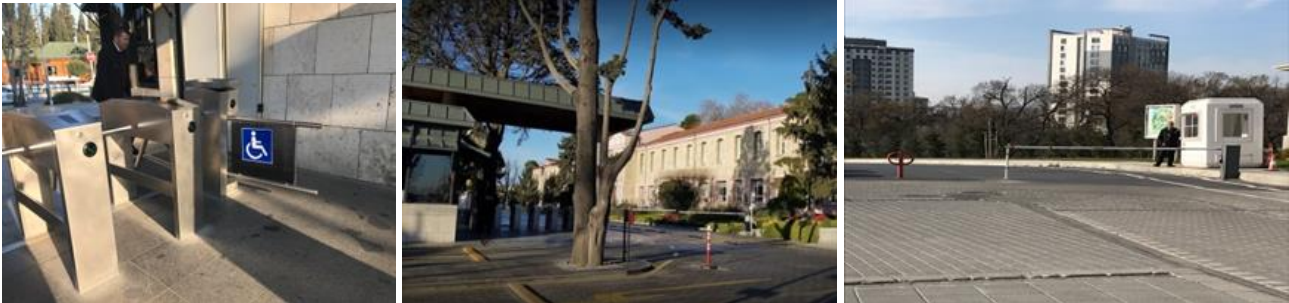
vehicle entrance and a pedestrian entrance. However, students are not allowed to move around the campus by vehicle, except in extraordinary circumstances. Width dimensions of the entries are sufficient. Since there is no slope in the entrance area, the ramp is not arranged. There should be a warning surface for visually impaired individuals on the road from the parking lot to the entrance area (Figures 4).

Fig 4: Entrance A and B

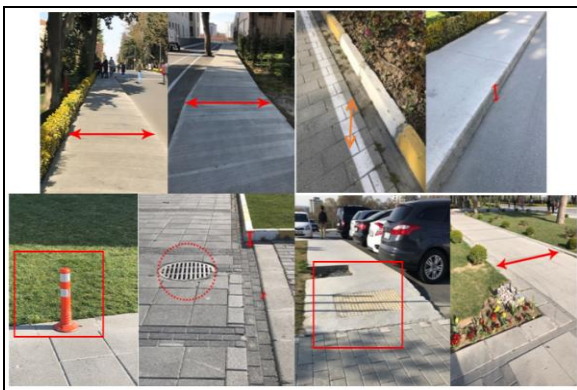
The widths of the walking paths in the campus are in variable sizes and are above the required length of at least 150 cm. In this direction, the movements of the wheelchair disabled individuals comply with the standards for their 90, 180, and 360 degree turns. In addition, the ground materials used on the roads comply with the standards. Differences in elevation from the flooring on the walking paths constitute a risk factor for wheelchair users and visually impaired individuals. Although warning signs are placed in some places to separate the road and greening areas from each other, a border should be laid along with the green space with a different color or texture from the ground material. To provide adequate drainage on the roads, necessary longitudinal or transverse slopes were given, and water gutters and grates were used. Some of the gratings used are dangerous as they are placed in walking areas (Figure 5).

Fig 5: On-Campus Pedestrian Walkways

- The varying heights of the curbstones used in landscaping and pedestrian walkways should be removed and painted with any contrasting color so that they can be easily recognized.

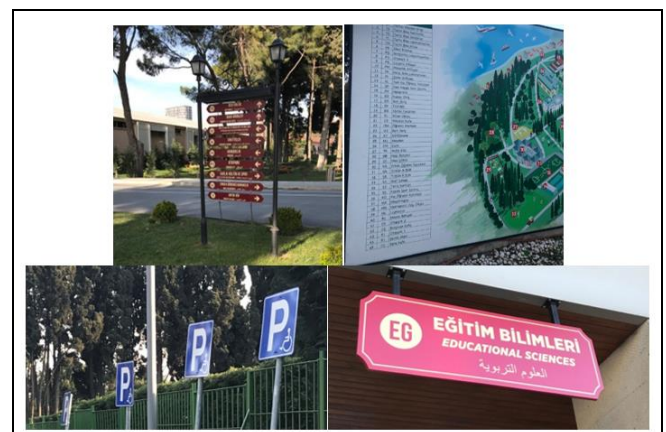
Direction, information, and warning signs used in the Halkalı campus are insufficient, and not all of them are illuminated. There are no embossed signs and audible warning signs for visually and deaf and hard-of-hearing individuals. Entrances of all buildings, parking lot entrances, and exits are indicated with signs. The fonts are large enough to be read (Figure 7).

Fig 7: Direction and Information Signs on Campus

- The number of information and direction signs should be increased, and care should be taken to ensure that their contents comply with national and international standards.

- Embossed and audible warning signs should be used for visually and hearing-impaired individuals.
 - A door or photocell door that can be applied as little as possible should be selected at the building entrances.
