Reliability test on existing ground water mapping in relation to performance in south western Nigeria: A case study of Abe Babalola University (ABAUD)

Abstract

This research was carried out with the aim to obtain a usable groundwater potential mapping of Afe Babalola University, Ado Ekiti. (ABUAD), using the performances rating of the drilled boreholes spread across the institution to validate an un-used groundwater potential map. Forty (40) boreholes that were drilled in the institution were subjected to evaluation and their coordinates were serially numbered and inserted into the existing Groundwater potential mapping. From the results obtained, Twenty- One (21) active boreholes were observed to have their site in locations that were designated as having good to moderate groundwater yield, Eleven (11) failed/dry boreholes had their site in locations that were considered as having good to moderate groundwater potential, Four (4) Active boreholes were also observed to be sited in area designated as having poor groundwater yield, while Four (4), were observed to be cited in areas designated as having poor groundwater yield. This results give a 66% approval rating that the groundwa

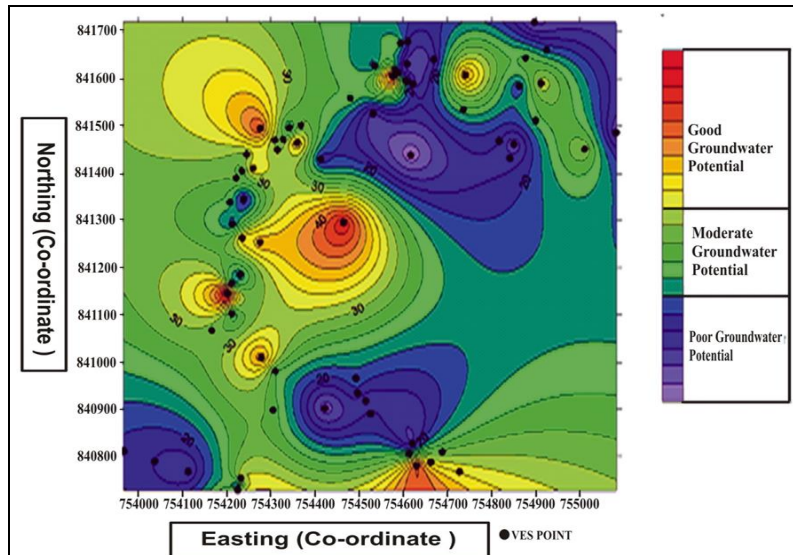
Fig 1: Groundwater Potential Map, Generated by Ademilua (2013) [1] resistivities, overburden thickness and bed topography to generate this groundwater potential

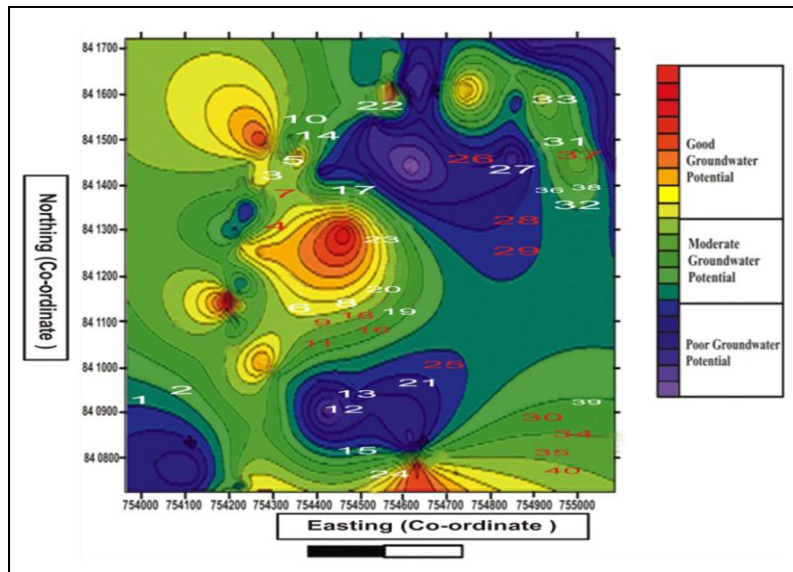
Fig 2: Groundwater Potential Map containing the physical locations of all Boreholes sited in Afe Babalola University Ado Ekiti as depicted in Numbers

Groundwater Potential Map containing Boreholes that have been evaluated and serially numbered according to the geographical locations (white figures indicate active boreholes, while red, indicate failed Boreholes).

The graph consist of the actual behavior of the boreholes in their respective sites, total numbers of Boreholes are Forty (40). Active boreholes sited in zones designated as Moderate to good are Twenty-one (21) in numbers, those that have failed but were sited in zones, designated as good to moderate are Eleven (11), Good/active boreholes site in zones designated as poor are Four (4), while failed boreholes sited in zones designated as poor are Four (4) numbers.

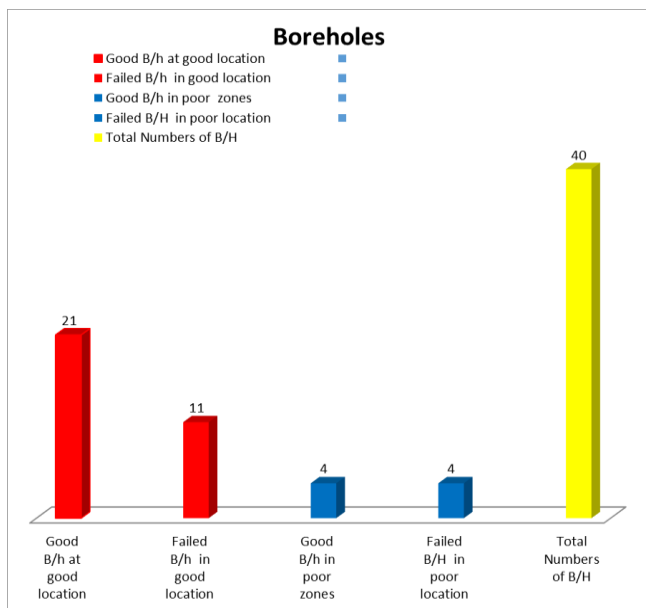
Graph 1: Pattern of Behaviours of Boreholes on the Map

The above results, describes the dependability coefficient of the existing groundwater potential map, 66% dependability is observed as the result of active boreholes situated in zones designated as moderate, 34% dependability on failed boreholes situated in areas designated as moderate, while 50% dependability on active boreholes in area designated as poor zones and 50% dependability on failed boreholes sited in area designated as poor zone.
