Impact of anthropogenic activities on Dal Lake (Ecosystem/conservation strategies and problems)

Abstract

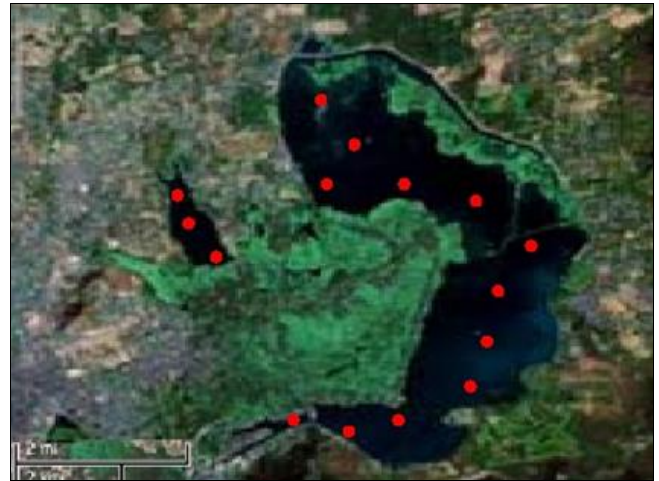
Fig 1: Satellite image of Dal Lake showing study sites (Courtesy: Google Earth)

sites were selected in the Dal Lake with 5 sites in Hazratbal basin, 4 in Lokut Dal basin, 3 in Gagribal basin and 3 in Nageen basin (Figure 1). Water samples were collected from all the sites during 2009-2013 on bimonthly basis in 2L polyethylene bottles. The samples were analyzed in the laboratory within 24 hours for different parameters adopting standard methods of Mackereth (1963) [15], CSIR (1974) [8], and APHA (1998) [1].
